# Sheeted Tower Scaffold Collapsed Onto Members of the Public

A construction company and its sole director have been fined after an incorrectly assembled tower scaffold overturned on a busy London high street, striking and trapping two members of the public and causing serious injuries.

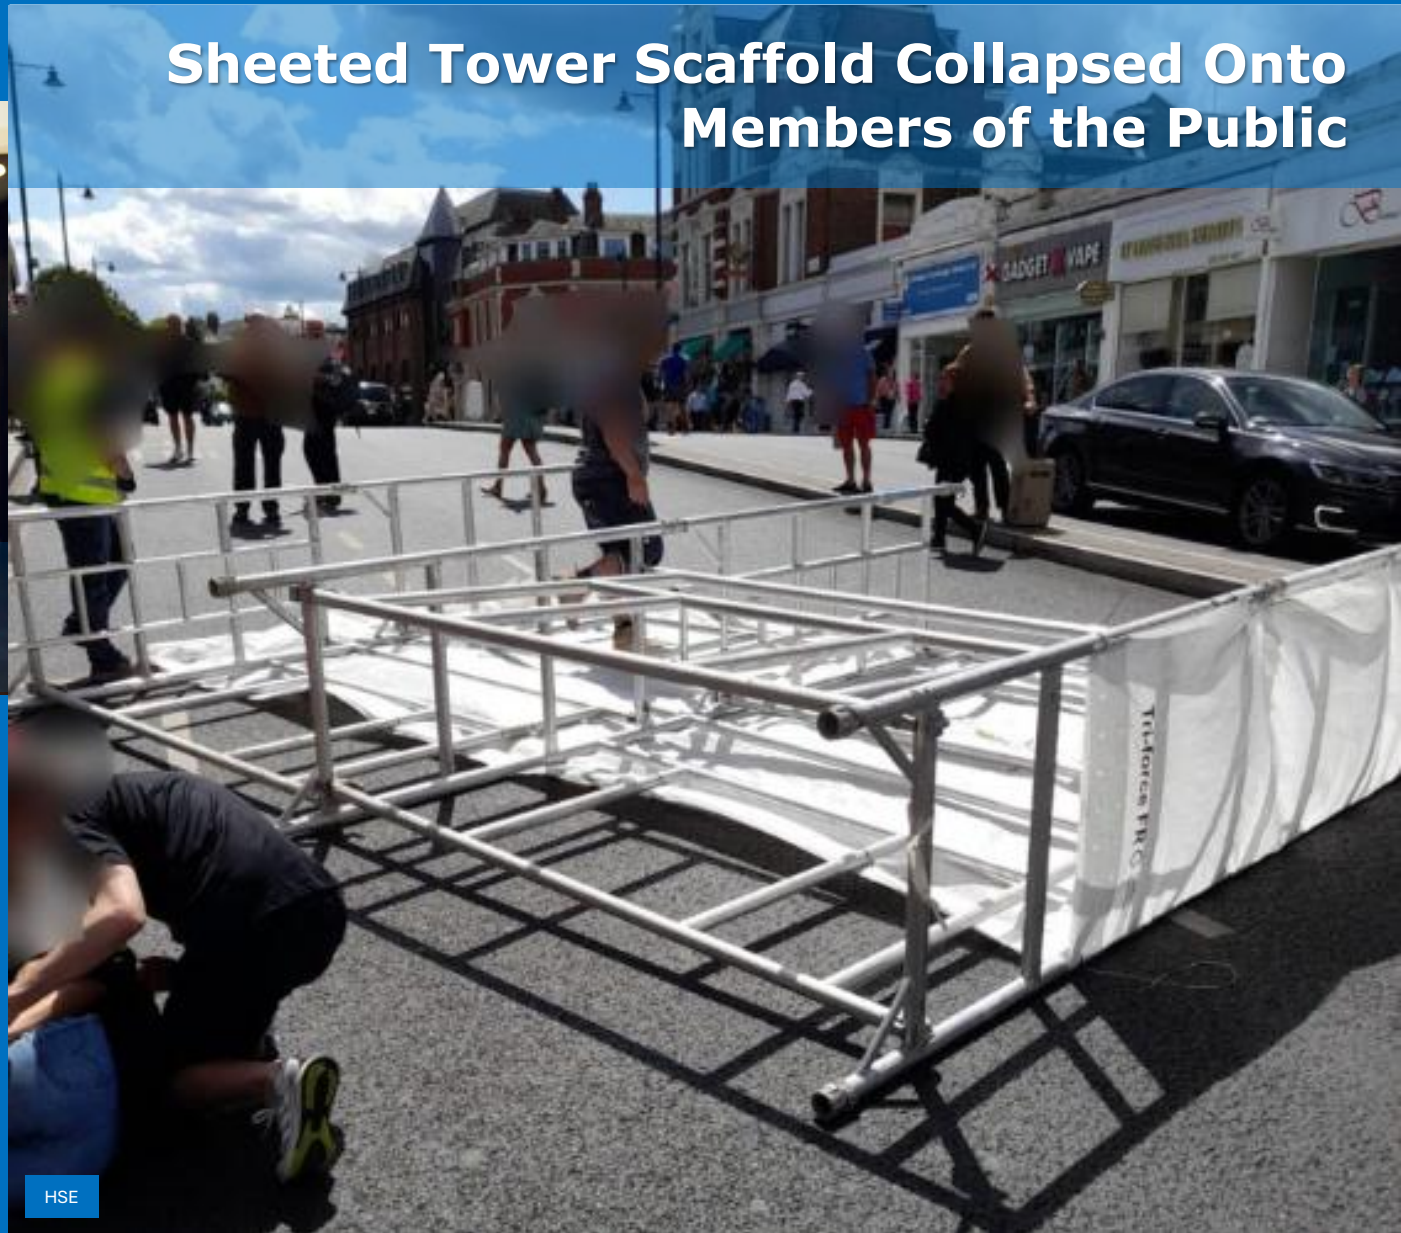
HSE

The scaffold had been covered with sheeting, which acted as a sail in windy conditions. The risks created by wind loading had not been adequately considered.

The tower had been assembled incorrectly and there were inadequate measures to separate the work from members of the public. It was subsequently covered with sheeting. In windy conditions, the sheeting acted as a sail, causing the scaffold to overturn. The structure fell onto two members of the public, trapping them and causing serious injuries.

An investigation by the Health and Safety Executive (HSE) found that the company had failed to ensure the temporary structure was designed, installed and maintained so that it could withstand foreseeable loads, including wind acting on the sheeting.

The scaffold had not been assembled or inspected by adequately trained and competent people and had not been erected in accordance with the manufacturer's instructions or established industry guidance.

- Tower scaffolds must be erected and inspected by appropriately trained and competent people.
- Manufacturer's instructions and recognised industry guidance should be followed when assembling tower scaffolds.
- Adding sheeting can significantly increase wind loading and affect the stability of a scaffold.
- Temporary structures must be capable of withstanding foreseeable environmental conditions, including wind.
- Work on or near public areas must include effective measures to protect and separate members of the public.
- Changes to a scaffold, such as adding sheeting, should prompt consideration of whether the existing risk assessment and stability arrangements remain adequate.

Sheeting should not be regarded as a minor addition to a scaffold. Wind acting against a sheeted surface can create substantial forces and increase the risk of overturning. Dutyholders should consider these additional loads before sheeting is installed and ensure that the structure remains stable under foreseeable conditions.

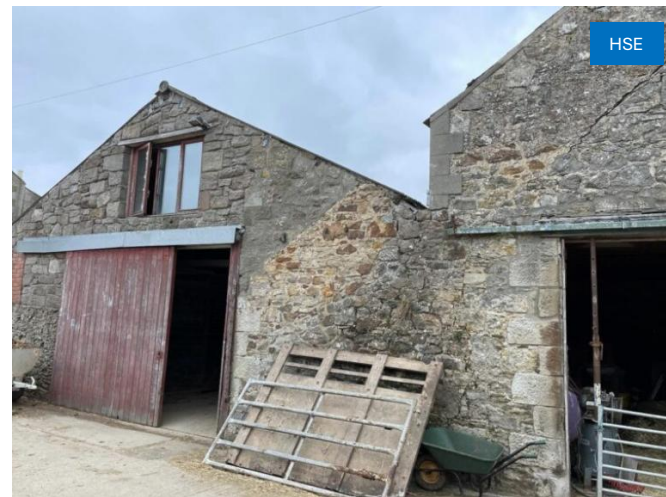
On 5 February 2025, the bricklayer was part of a team carrying out repairs to the roof of a barn. While working on the roof, he stepped onto a polycarbonate roof sheet and fell through it, landing on the concrete floor below.

The worker had been carrying out roof repairs to the barn when he stepped on a polycarbonate roof sheet and fell approximately eight feet to the concrete floor below

- Fragile roof surfaces must be identified before work begins and treated as a significant fall risk.
- Work at height must be properly planned and subject to a suitable and sufficient risk assessment.
- Safe systems of work and appropriate fall-prevention measures must be established before roof work starts.
- Employers must ensure employees and contractors are protected from the risks associated with working at height.

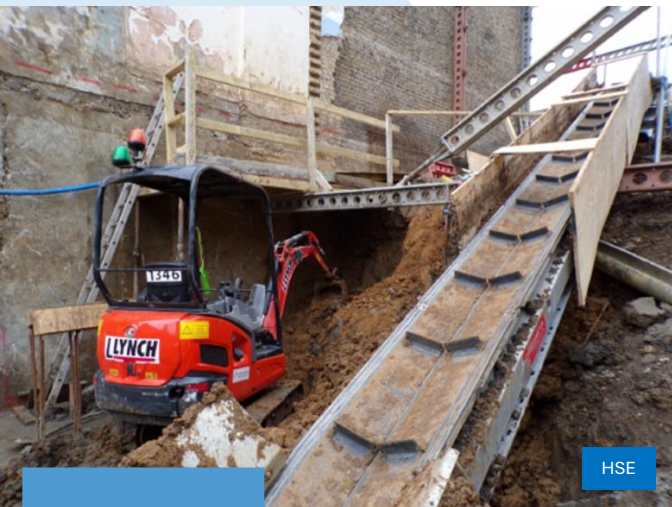
Excavation and stability structure concerns

- The stability of structures.
- Excavation work.
- Work at height.
- Management and supervision arrangements.

The failings resulted in multiple enforcement notices being issued. HSE stated that appropriate measures, including properly planning the work and shoring the excavation walls, could have prevented the incident.

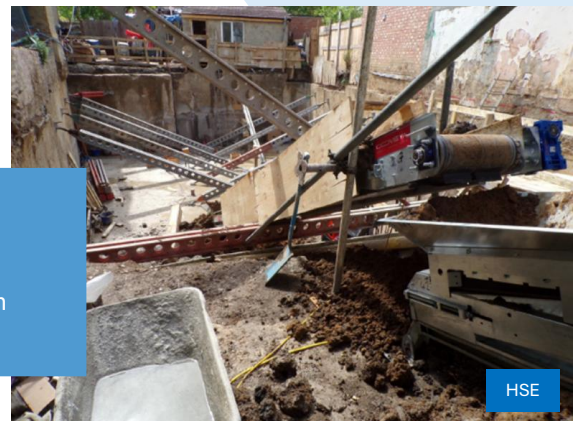
Fall risk from open edge

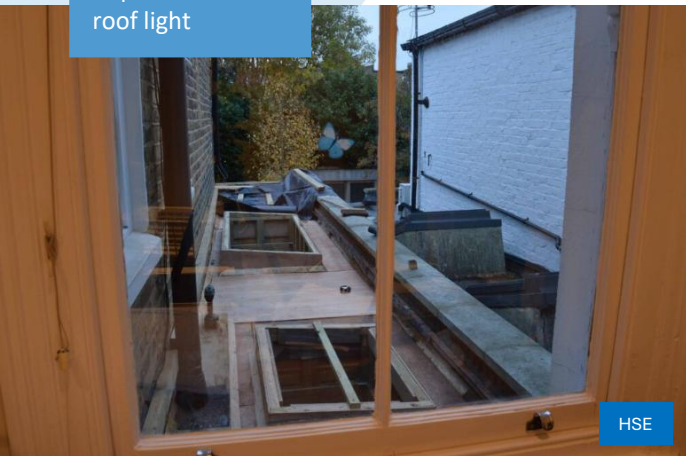
On 10 November 2023, a worker was carrying out roof refurbishment work at a property in Fulham. While passing materials through an open and unprotected roof light, he fell through the opening onto the concrete floor below, sustaining serious injuries.

The  
unprotected  
roof light

Suitable precautions such as scaffolding, guard rails, an internal crash deck or harness systems had not been provided.

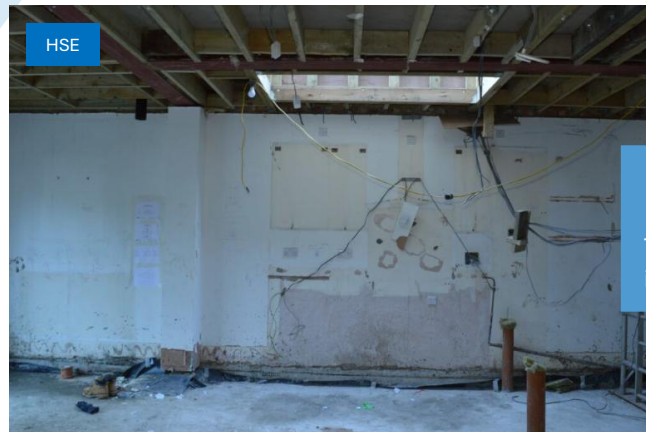
The area where the  
injured person fell

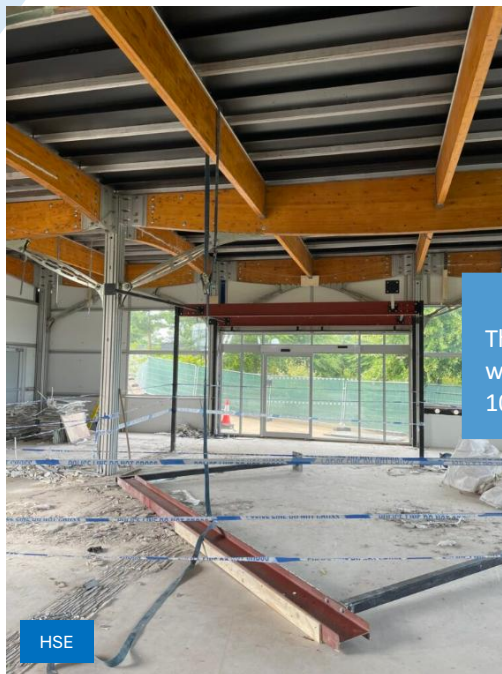
The incident occurred in Surrey in June 2024 while workers were dismantling an internal temporary steel frame. A ratchet strap was being used to lower a steel beam weighing more than 100kg. However, the strap was not designed for lifting or lowering loads. It failed, causing the beam to fall onto a 38-year-old employee.

The steel beam weighing over 100kg

HSE guidance states that demolition and dismantling arrangements should be established in writing before work begins. A safe system of work, such as a method statement, should identify the sequence of work required to prevent accidental collapse.

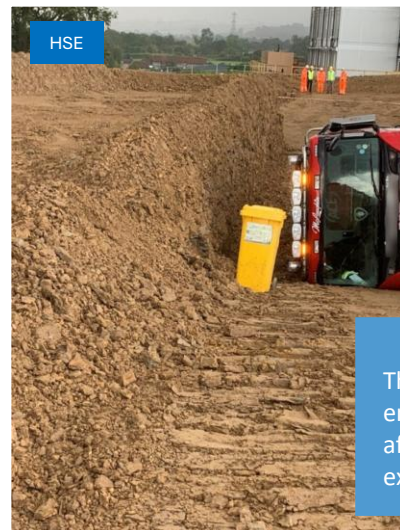
The first tipper truck driver subsequently used the higher-level bank rather than the intended route and his vehicle slipped on the ramp. A second driver followed the same route, but his vehicle veered over the edge of the bank. The truck fell approximately two metres and landed on its driver's side. The driver suffered a broken nose, a cut to his hand and a shoulder injury.

HSE inspectors visited the site following the incident. They found that there were no signs on the haulage routes being used and no edge protection to prevent vehicles from travelling over the edge of the ramp. Inspectors also identified excavations adjacent to some vehicle routes with unsupported vertical faces that were at risk of collapse. The investigation established that the change to the working area and traffic route had inadvertently created an unprotected edge. The arrangements in place were insufficient to ensure that drivers followed the intended new route safely.

The 20-tonne truck ended up on its side after falling off excavation edge

- Changes to vehicle routes should be properly planned, assessed and communicated before they are brought into use.
- Suitable physical edge protection, such as safety banks, should be provided where vehicles operate close to excavations or other significant drops.
- Haul routes should be clearly defined so that drivers can readily identify the route they are expected to follow.
- Changes to working arrangements can introduce new hazards and should trigger a review of the relevant risk controls.
- Excavations should be designed and managed to prevent collapse, including where they are located alongside vehicle routes.
- Haul roads on construction sites should be appropriately managed as temporary works.

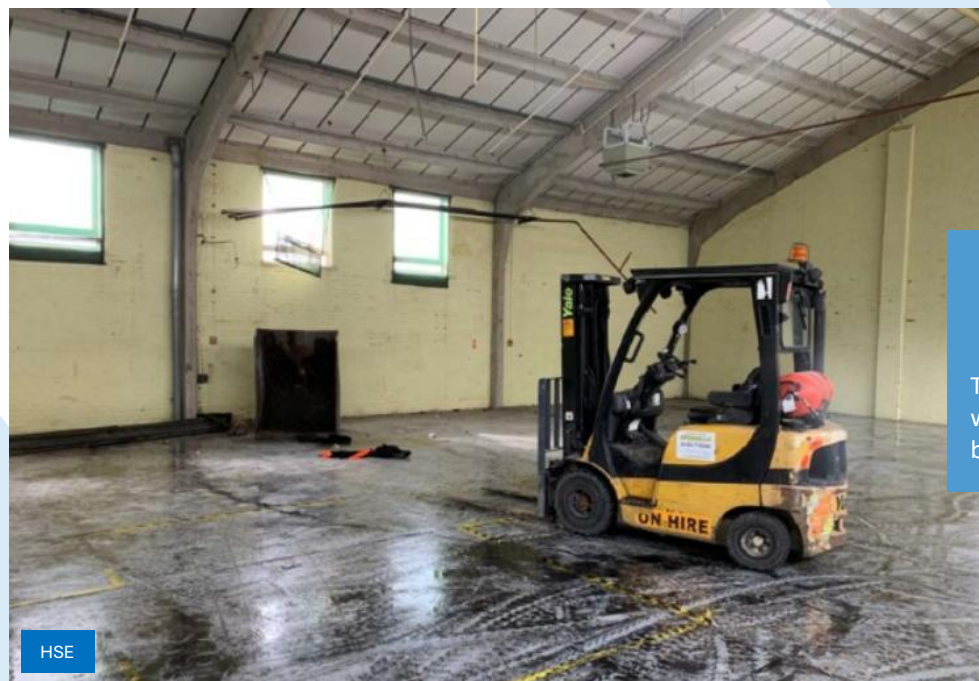
The fork lift truck used with the bucket in the background

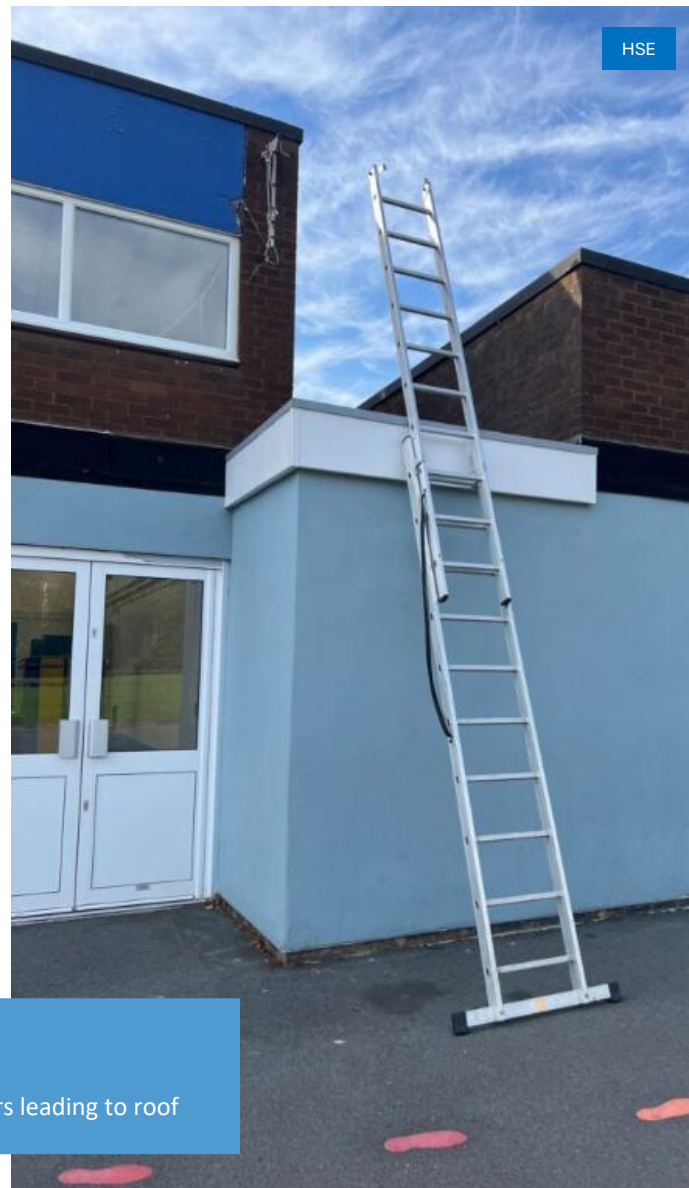
The site supervisor was working at a primary school during an inset day in September 2024. He used an unsecured ladder to access the school roof to retrieve footballs. While on the roof, he fell onto the concrete playground below and was later found by a member of the public.

An investigation by the Health and Safety Executive (HSE) found that there was no edge protection or other means of preventing or mitigating a fall from the roof.

Ladders leading to roof
